REPORT
ON ASSESSMENT OF
ENERGY CONSERVATION MEASURES
AT PLANT LEVEL IN MALAYSIA*

UNIDO Secretariat**

M. Eguchi, Energy Management Expert (Mission Leader);
R. Takahashi, Thermal Energy Management Expert;
T. Sugimoto, Electrical Energy Management Expert.

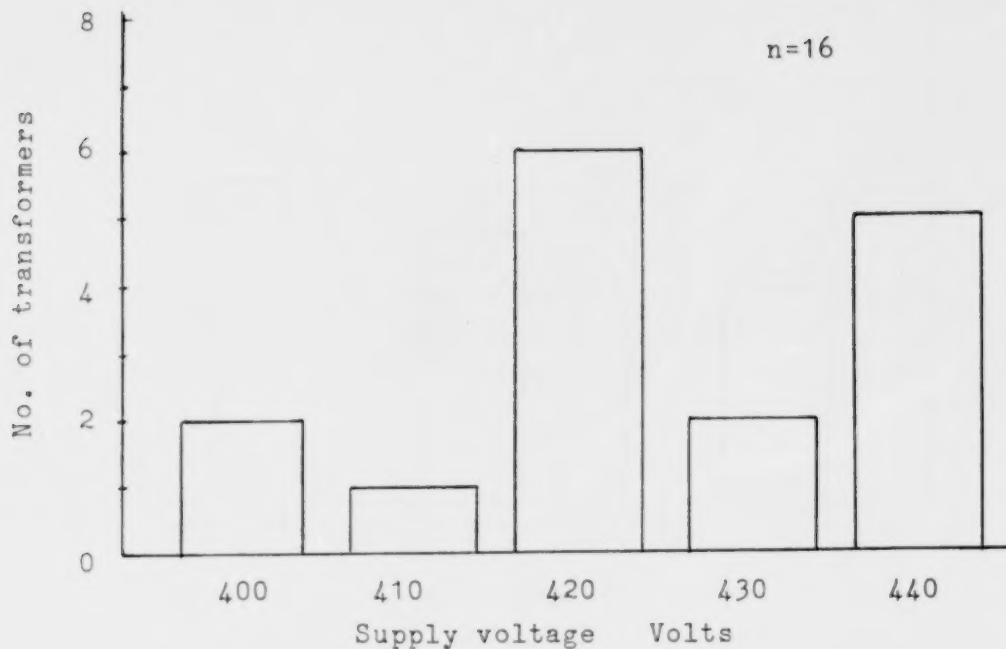
Figure 6.3.2 The secondary supply voltage histogram of transformers in the factories

The name plate ratings of various equipments and motors value almost between 400 volts to 420 volts, but the supply voltages of the six factories were kept between 420 volts to 440 volts, remainder factory's supply voltage were lower than the rating voltage of equipments. The supply voltage histogram of the various factor is given in Figure 6.3.2.

Only six transformers in two factories were maintained at comparatively good voltage between 420 volts and 430 volts while others were either too low or too high.

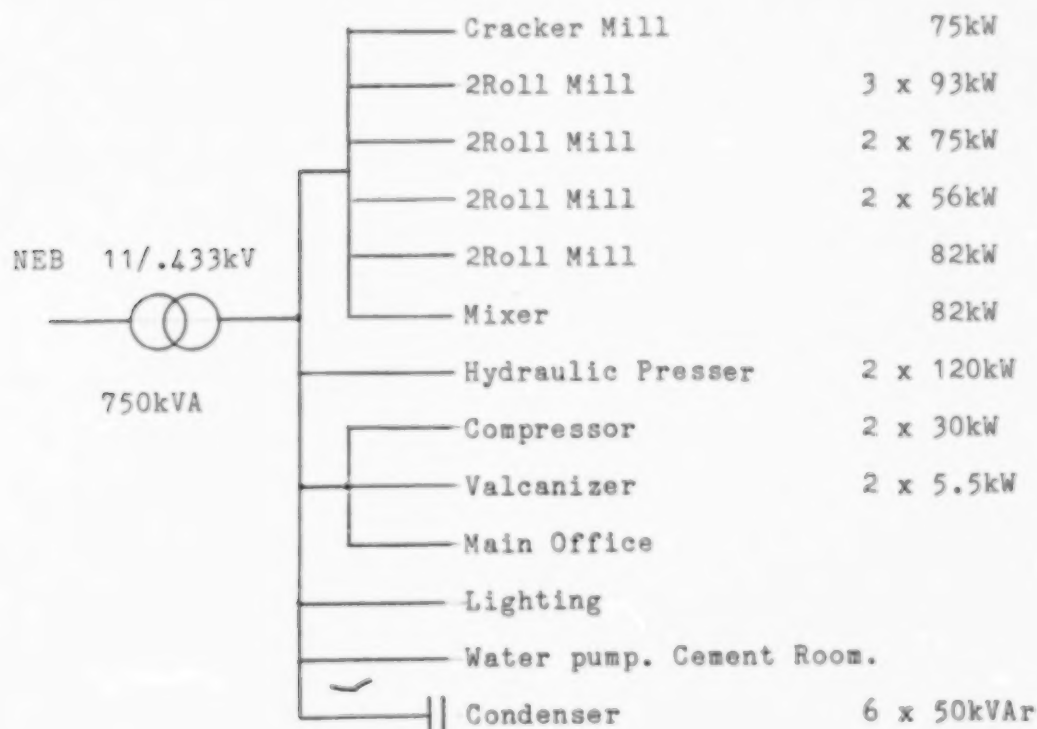
Figure 7.1 Electrical schematic diagram of MARCO SHOES BHD.

The source is connected to a 750 kVA, 3 phase transformer. The average loading is 430 kW (467 kVA assuming a 0.9 power factor) of which 50 % is utilized by the large open roll mills and 40 % by other equipments in the factory. The remaining 10 % is for lighting and air conditioning.

Actual unbalanced in phase current of about 10% was detected. This is an undesirable condition because an unbalanced current would create an unbalanced supply voltage which in turn create negative torque in most three phase motors. Therefore effort is required to redistribute some of the single phase loads.

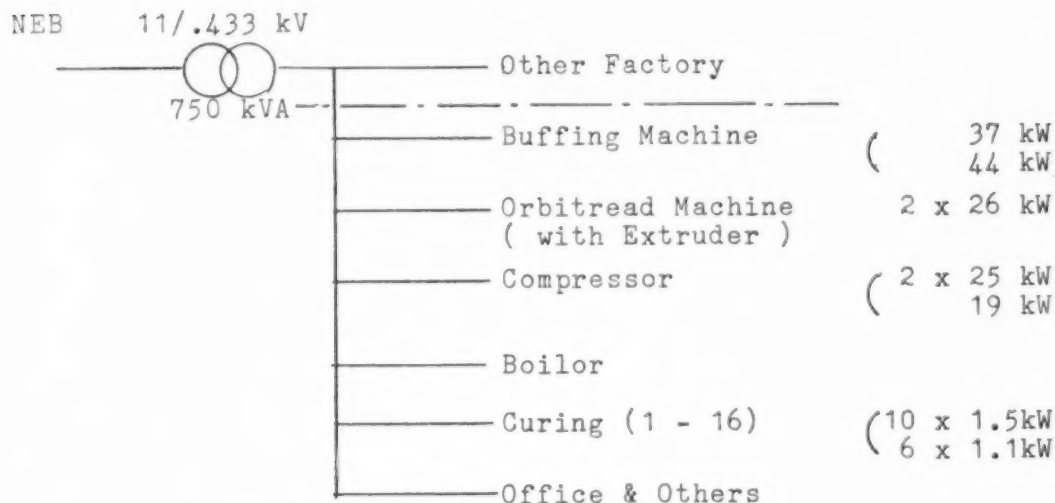
Figure 7.1 Electrical schematic diagram of USMETA SND BHD.

It was observed that the incoming switch board compartment is permanently water-logged. This is a dangerous condition, where accidents can happen during both switching and maintenance. In addition to this, the condition of the switchboard and the associated wirings are in poor condition. It is highly recommended that measures should be taken immediately to keep the switch board room completely dry.

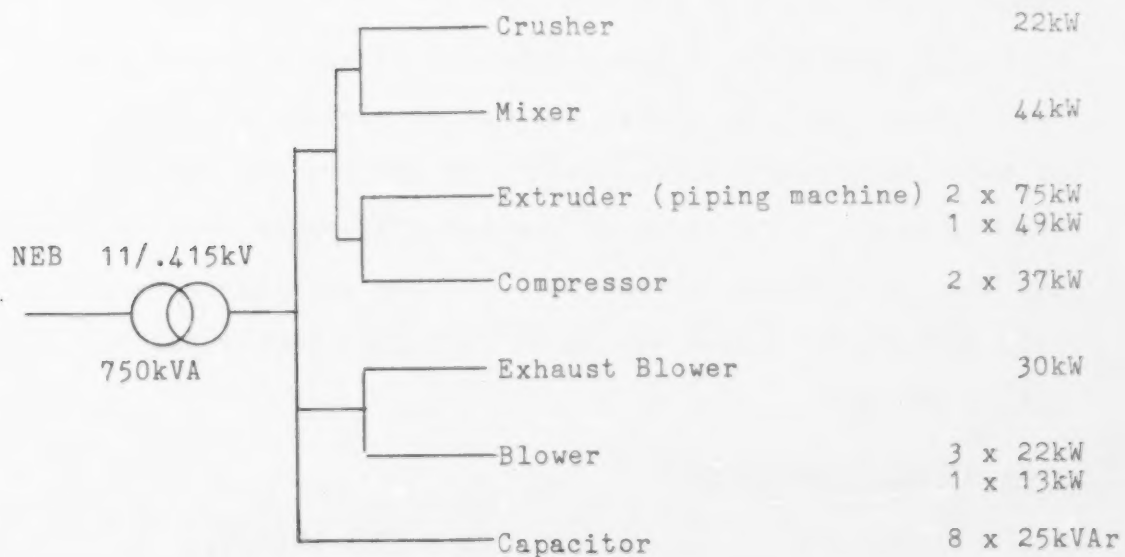
Figure 7.1 Electrical schematic diagram of GOH BAN HUAT POTTERY WORK.

The new factory which we have investigated make earthen ware sewage pipes utilizing automatic extruding machines, kilns and some electric pressers. power input is through a 750 kVA, 3 phase transformer and maximum load demand is estimated around 250 kVA where 60% of the factory load demand is taken up by the automatic extruding machines and the remainder by the kilns, dryers and other general purposes.

The main substation transformer is rated 750 kVA but average power requirement is about 236 kW (278 kVA assuming 0.9 p.f) It is obvious that this transformer capacity is too large for the factory. To save energy it is recommended that the substation capacity be reduced to 450 kVA. Further energy saving can also be realized if two transformers with capacity of 250 kVA and 200 kVA each be installed instead of one 450 kVA, where only the 200 kVA transformer is connected outside working hours. This measure will save energy as indicated by the calculation below.

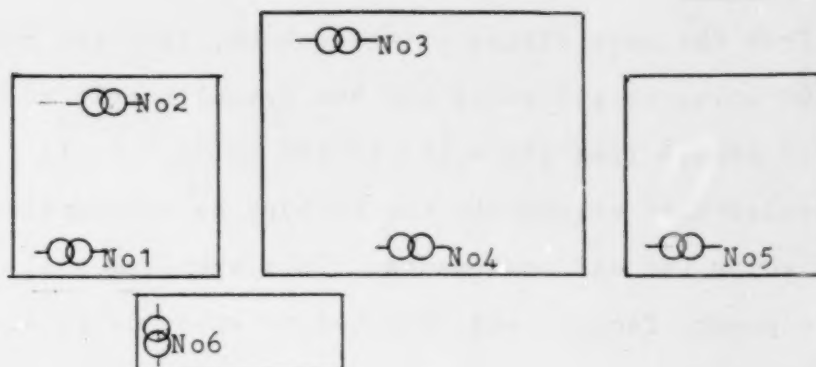
Table 8.1 Load conditions of transformers

Trans- former No	Rating (kVA)	Actual load conne- cted (kW)	Measured data			Load factor
			Voltage (V)	Power consum- ed (kW)	Power factor	
1	1500	1243	417	607	0.89	0.45
2	1500	593	431	315	0.86	0.24
3	750	515	410	405	0.94	0.57
4	800	347	424	209	0.96	0.27
5	750	1050	423	185	0.90	0.27
6	800	424	430	213	0.93	0.29
Total	6100	4172	-	1934	0.91	0.35
